Report: Ecological water quality assessment of the Mpanga catchment, Western Uganda

Van Butsel, J., Donoso, N., Gobeyn, S., De Troyer, N., Van Echelpoel, W., Lock, K., Bwambale, G., Muganzi, E., Muhangi, C., Nalumansi, N., Peeters, L., Goethals, P.L.M. (2017). Report: Ecological water quality assessment of the Mpanga catchment, Western Uganda. Ghent University, 37 pages.

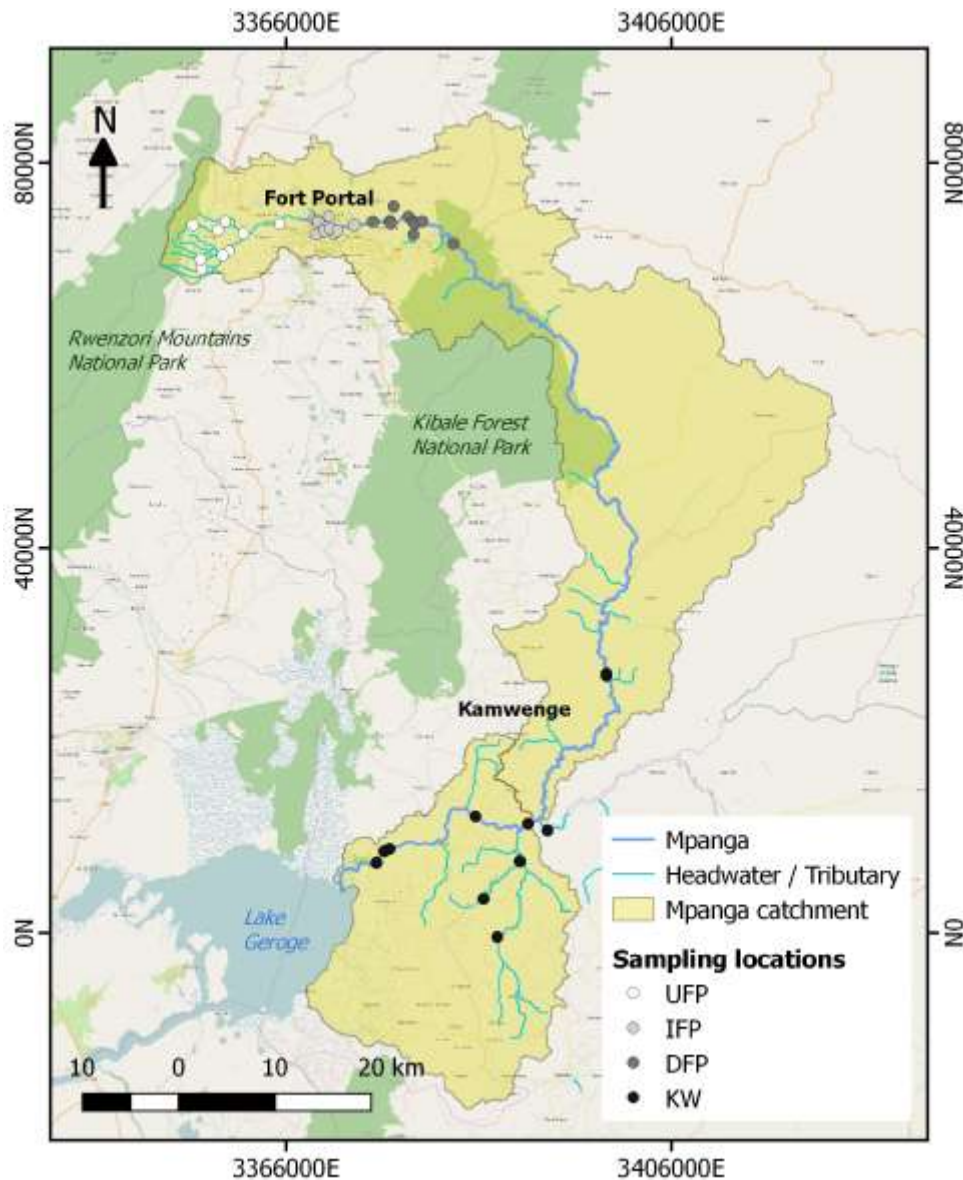
Figure 1. Map of the Mpanga catchment with indication of sampling locations per area (UFP = upstream Fort Portal; IFP = in Fort Portal; DFP = downstream Fort Portal; KW = Kamwenge).

The aim of the study was to provide an overview of the ecological state of the surface waters within the Mpanga catchment. Sampling locations were chosen to include both the diversity of the catchment's environment as well as potentially relevant impact areas. 43 sampling sites were selected, spread over four areas further referred to as 'upstream Fort Portal' (UFP), 'in Fort Portal' (IFP), 'downstream Fort Portal' (DFP) and 'Kamwenge' (KW) (Table 1, Figure 1). Table 1 contains information on the main surrounding land use and of particular impact factors in proximity of the sampling sites. The number of reference sites (sites with minimal human impact) is limited to few locations at the mountains' foothills upstream of Fort Portal. Access to pristine (source) sites was limited because rural habitations, agricultural activity and sand/stone mining continue until high up on the Rwenzori mountains' slopes, where no driveable paths lead to. The most upstream samples included in the study area lie at the Rwenzori foothills (> 1700 m a.s.l.) and the most downstream site is located at the powerhouse of the Mpanga Hydropower Station (Kamwenge), downstream of the dam (950 m a.s.l.), at short distance from Lake George.

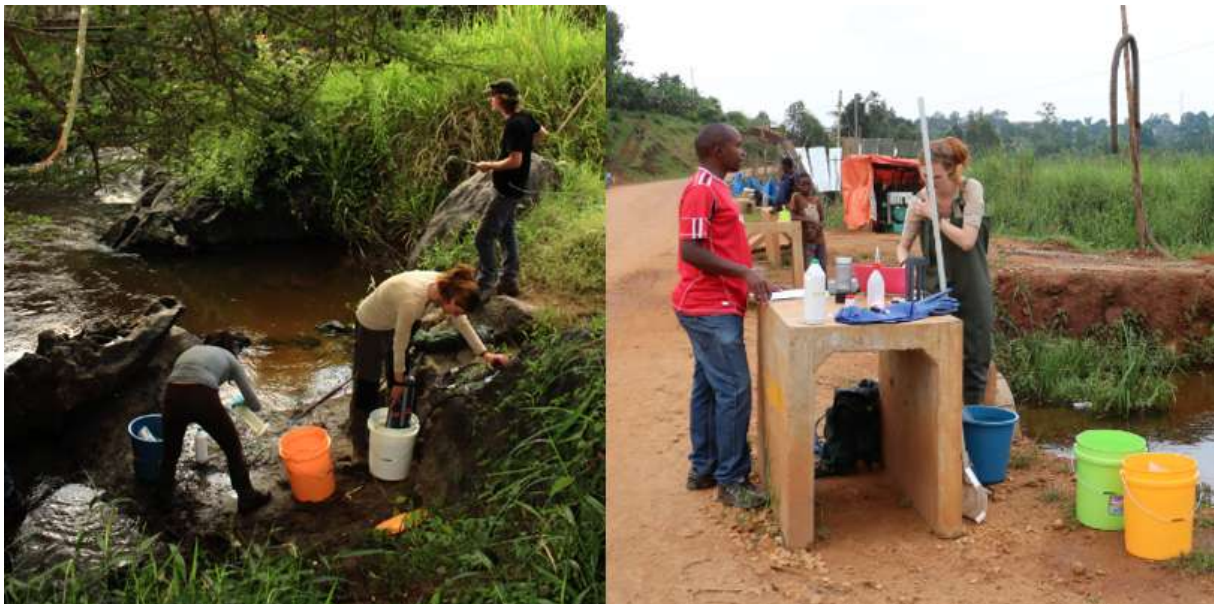
Figure 2. Measuring variables in the field and collecting water samples for analysis in the laboratory.

On-site measurements were done with YSI multiparameter probes (YSI 6600 and YSI 6920), equipped with sensors for temperature, electric conductivity (EC), pH, dissolved oxygen (DO), turbidity and in-vivo chlorophyll a (chl-a). The sensors were calibrated weekly with commercially available standard solutions. On site, the measurements were done in a sample collected in a large bucket (Figure 2).

For variables that could not be measured in the field, water samples were collected for analysis in the laboratory at Mountains of the Moon University (Figure 2). This was done for ammonium (NH_4), nitrite (NO_2), nitrate (NO_3), total nitrogen (TotN), total phosphorus (TotP), dissolved orthophosphates (o-PO_4), chemical oxygen demand (COD), biochemical oxygen demand (BOD) and total, inorganic and

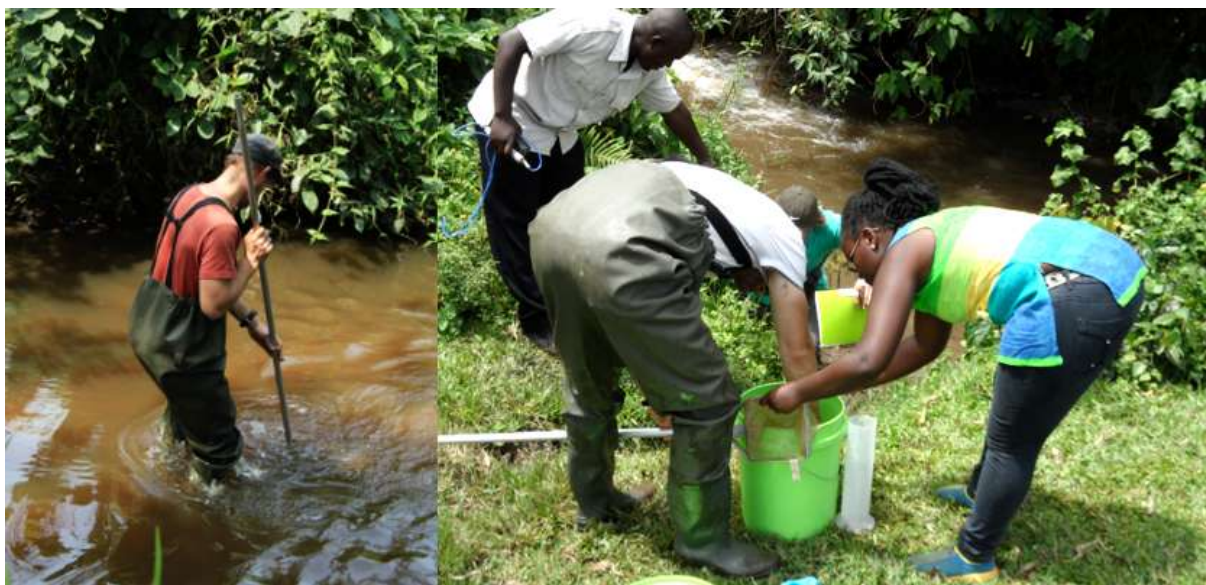
Figure 3. Macroinvertebrate collection by kick-sampling using a hand net (left), and transfer of the sample into buckets for transportation to the laboratory (right).

Macroinvertebrate samples were collected using the hand net and kick-sampling method (WAC/I/A/006). Hereby, macroinvertebrates are dislodged and collected in a hand net (mesh size 0.5 mm) by kicking the stream bed substrate while the net is held directly downstream of the whirled up sediment (Figure 3). Per sampling location, a stretch of 10-20 m, not necessarily continuous, was selected to cover as many microhabitats as possible (bank vegetation, submerged roots and branches, large boulders and different substrate types, ...). Kick-sampling was limited to 5 minutes of active sampling, and where applicable, large boulders or particular structures were swiped by hand to collect attached animals that would be missed by only kicking. The sample was then transferred to a large bucket filled about 1/3 with stream water, closed by lid and transported to the laboratory for fresh processing. Keeping macroinvertebrates alive (unpreserved) helps in the sorting process because animals are more visible as they move and they retain their original body shape and colour. In the laboratory, samples were rinsed over 10 mm, 1 mm and 0.5 mm mesh size sieves. The different fractions were then transferred to white sorting trays and carefully checked for animals. Animals were sorted into taxonomic groups, stored in small recipients with 95% ethanol within 24h after sampling and transported to Belgium for identification to family level.

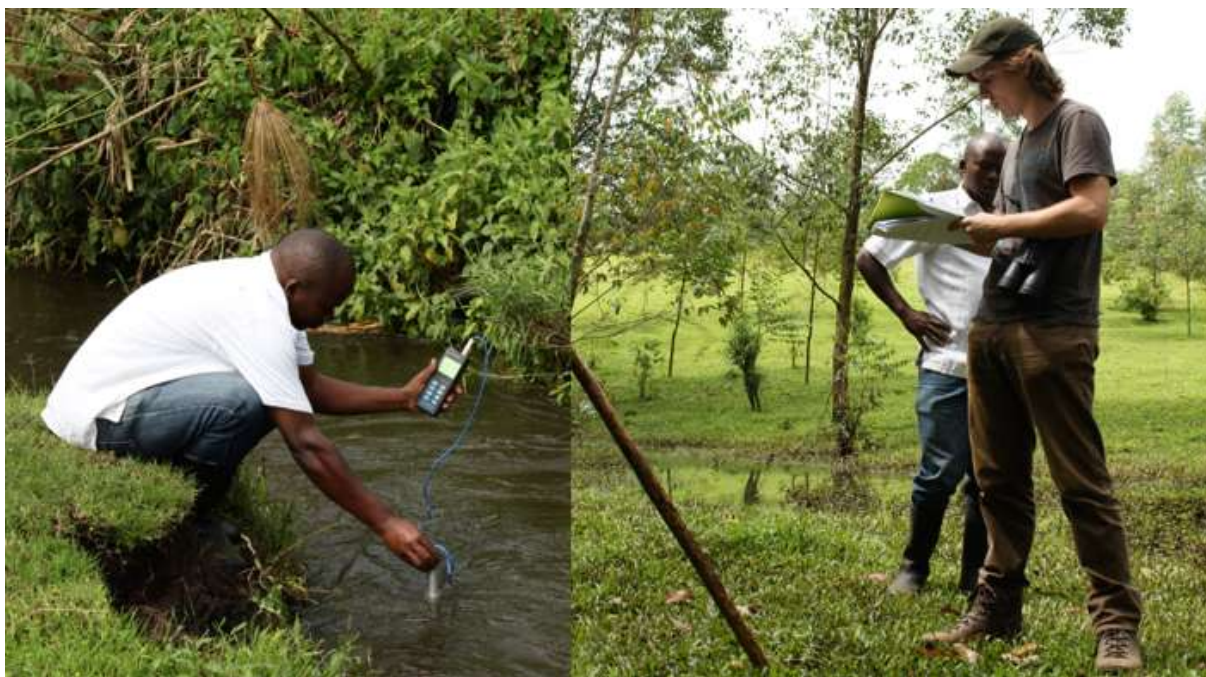
Figure 4. Recording stream velocity and completing the sampling site description form.

Hydromorphological characteristics like stream velocity, stream and sampling depth, substrate composition and presence of aquatic vegetation were recorded on site (Figure 4), using the field protocol used by the AECO research group (see Appendix), complemented by the standard form from the Belgian Compendium for Water Analysis (WAC/I/A/006).

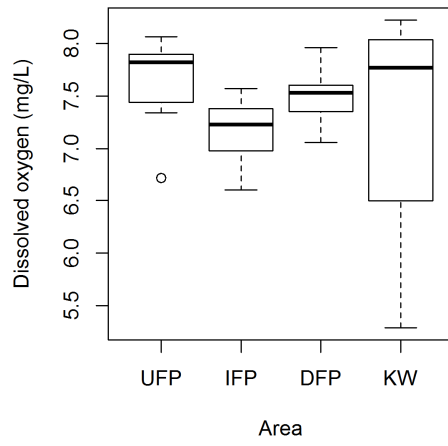
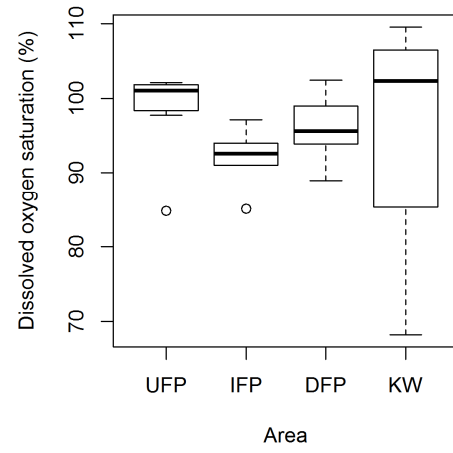
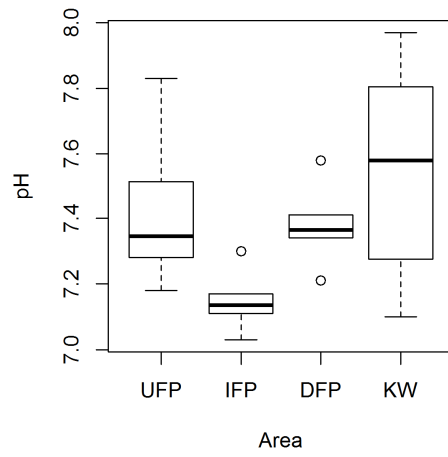
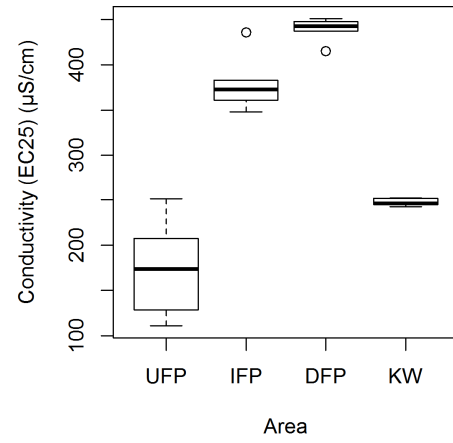
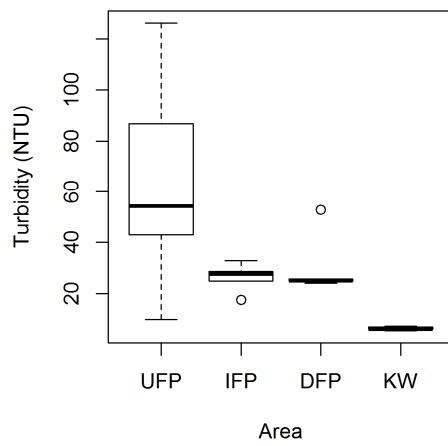
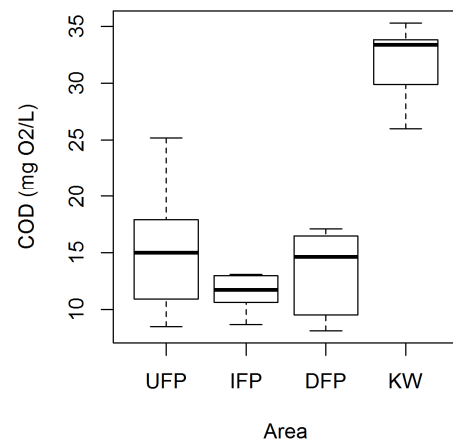
Figure 5. Box-Whisker plots of environmental variables measured in the headwaters and Mpanga main channel (excluding tributaries), grouped per areas UFP, IFP, DFP and KW. The black line gives the sample median and the surrounding box the 25 and 75% percentiles. Whiskers give the 95% percentiles, whereas single points are outliers. The number of samples n per area is: $n_{UFP}=8$, $n_{IFP}=6$, $n_{DFP}=6$, $n_{KW}=7$.

Water composition was found to change substantially for some variables in the Mpanga main channel as it flows from headwaters to Lake George. The panels in Figure 5 show the evolution of some of these variables in the Mpanga main channel per sampling area.

The observed pattern in biological quality is similar to that of DO, pH and the reverse of Conductivity. Except at KW7 and KW11, where DO saturation drops just below 60%, oxygen saturation in the main channel remains above 80% local saturation or 6.5 mg O₂/L, which is considered a safe threshold for most local aquatic life. DO is thus unlikely to be the direct cause of the decline in number of taxa, although it may affect the most sensitive ones on the long term. Conductivity and the pollution sources that cause its rise are thus more probably the variables that make the habitat unsuitable for many macroinvertebrate species. Another relevant quality issue is the river bank modification in the urban area that prevents natural bank vegetation to develop and provide a suitable habitat for those species that depend on it. Both water and river bank quality improve downstream of Fort Portal as buffer zones and vegetation reappear around the river banks and allow biodiversity to recover to some extent before entering Kibale Forest. In the main channel in Kamwenge almost equal amounts of taxa are present as in the headwaters. The fact that the ASPT did not recover to the same extent may be due to the surrounding agricultural land use, as is also reflected in the more elevated concentration of nitrates in this area (Figure 5), which might prevent some sensitive taxa from settling there.

lower turbidity compared to other UFP locations (Figure 5). The contrast is largest when compared to location UFP9, which is situated just 3 km downstream of UFP8, but showing the cumulative effect of the numerous extraction spots upstream. Sediment in the southern headwaters is being removed by workers of the Karangura Stone Quarry, which is reflected in the high turbidity in locations UFP5 and UFP10. At the moment of sampling these two locations, it had started to rain, which likely caused the turbidity to be even higher than usual, while at the same time it illustrates how the flushing of fine matter can suddenly peak within a short time. Compared to UFP8, sites after sand mining areas (UFP5, UFP7, UFP9 and UFP10) show higher levels of nutrients and conductivity, which is due to the combined effect of the sediment extraction activities (Figure 8), as well as runoff from the agricultural land on the mountain slopes (Figure 9).

The land in Kamwenge is characterised by intense small scale agricultural activity. This is mostly reflected in the elevated concentrations of nitrate, compared to the DFP area (Figure 5) and the many places along the river where banks are trampled by cattle. The effects on chemical and biological quality, however, differ strongly per location. The lowest biodiversity was found in the Kyebonekeere tributary (KW8), marked by strong oxygen depletion, and likewise, the Bigera tributary (KW10) had a low ASPT, likely due to its low oxygen content. In contrast, at the downstream confluence of these tributaries (KW6), water quality is much better, indicating that the pressure sources that impair Ruambo and Bigera act only locally and on a limited stretch of the stream with no relevant impact on the quality in the Mpanga main channel.

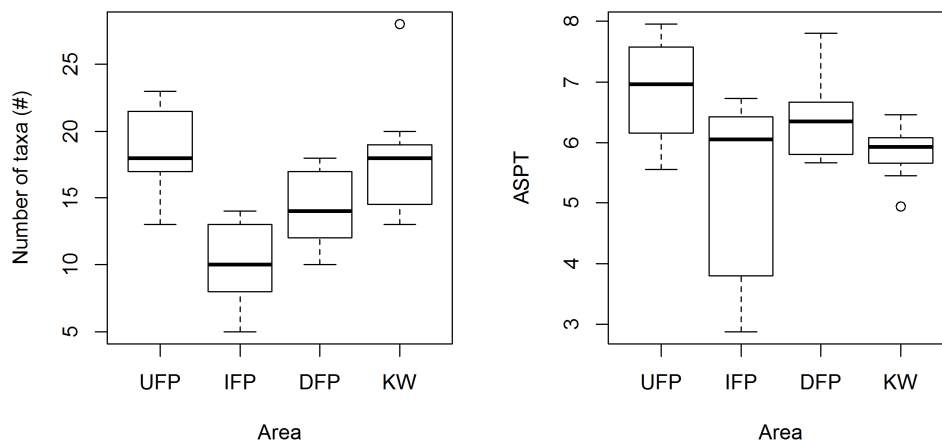
Figure 6. Box-Whisker plot of the number of taxa and of the average score per taxon (ASPT) in the headwaters and Mpanga main channel (excluding tributaries), grouped per areas UFP, IFP, DFP and KW. The black line gives the sample median and the surrounding box the 25 and 75% percentiles. Whiskers give the 95% percentiles, whereas single points are outliers. The number of samples n per area is: $n_{UFP}=8$, $n_{IFP}=6$, $n_{DFP}=6$, $n_{KW}=7$.

A simple indicator of biodiversity is the sum of taxa (#taxa), in this case families, that are present at a location. The average score per taxon (ASPT) in a sample gives an indication of how adapted the local macroinvertebrate community is to disturbances. Typically, undisturbed natural locations can harbour more (higher #taxa) and more sensitive (higher ASPT) taxa (families) than polluted or otherwise disturbed habitats. The panels in Figure 6 show the median number of taxa and the ASPT in the main channel in the different sampling areas, and Figures 7 A-D give detailed views on the biological quality indices in the four sampling areas. The headwaters are in general the most taxon-rich and also harbour the most sensitive communities. In Fort Portal, only about half as many taxa are found and some of the communities are reduced to only a few resistant taxa as indicated by the low ASPT. But biodiversity

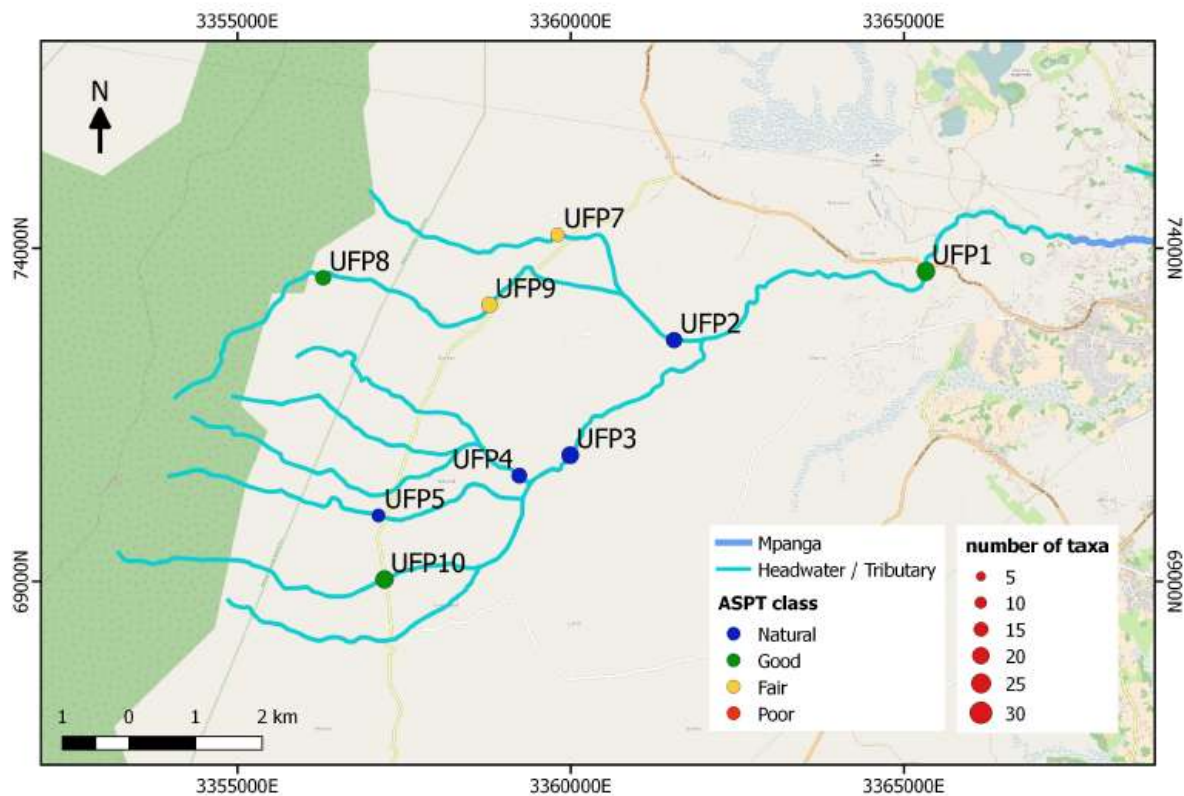
Figure 7 A. Detailed view on the biological quality indices for the Mpanga source area, upstream of Fort Portal.

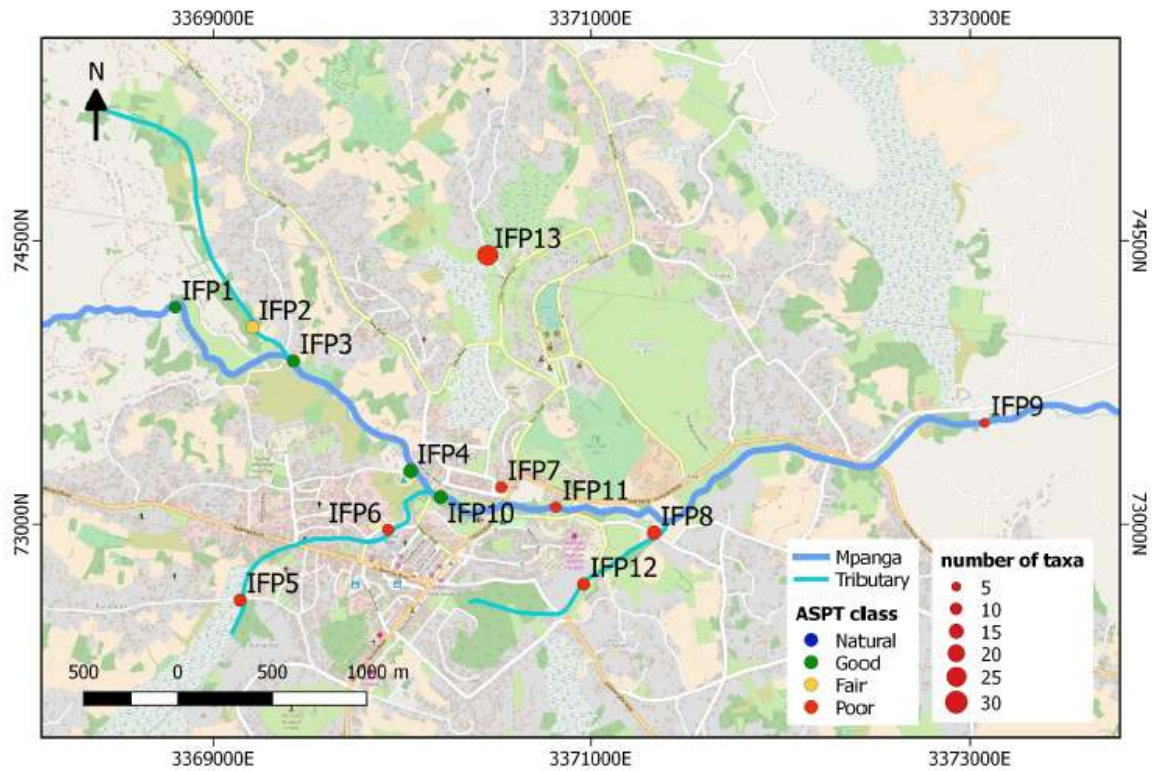
Figure 7 B. Detailed view on the biological quality indices for the sampling area in Fort Portal.

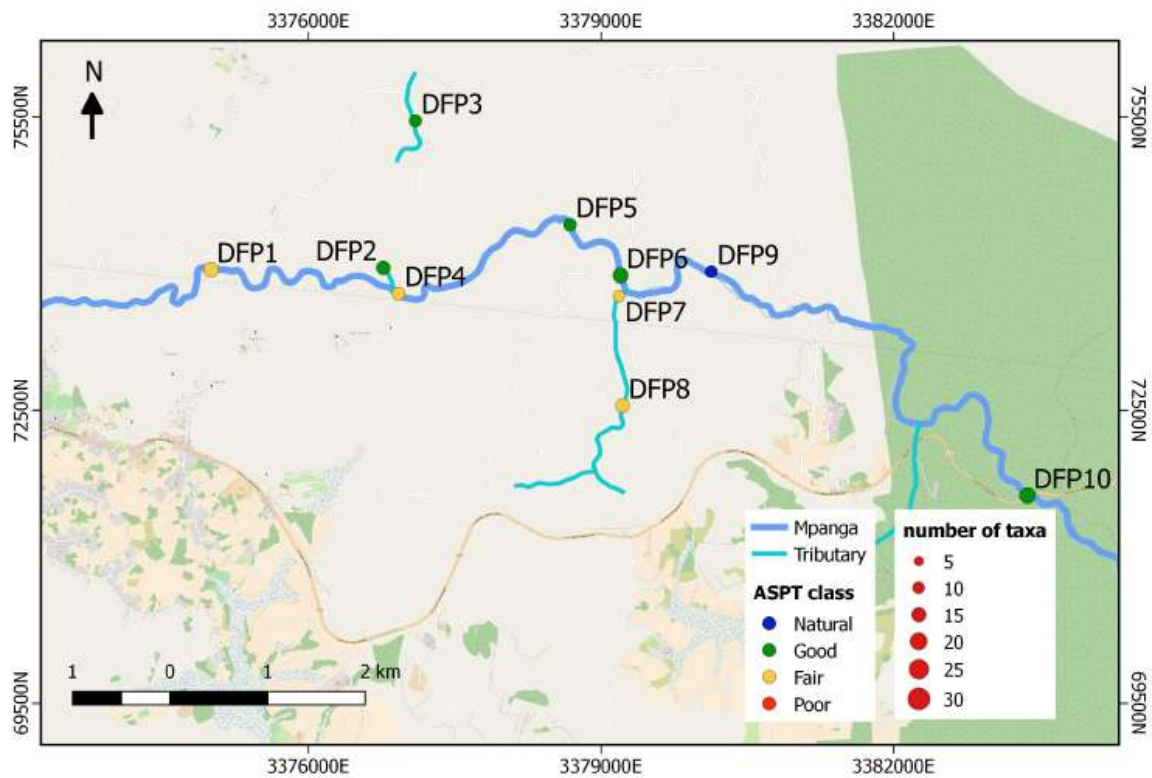
Figure 7 C. Detailed view on the biological quality indices for the sampling area downstream of Fort Portal.

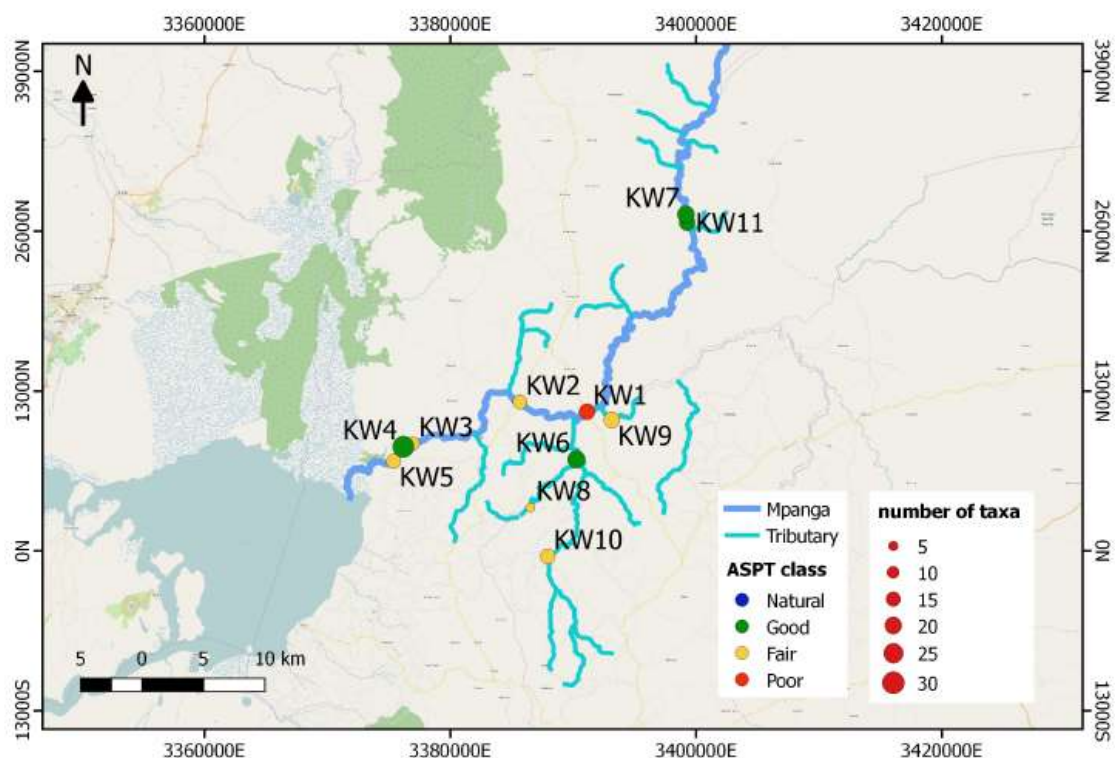
Figure 7 D. Detailed view on the biological quality indices for the sampling area in Kamwenge.

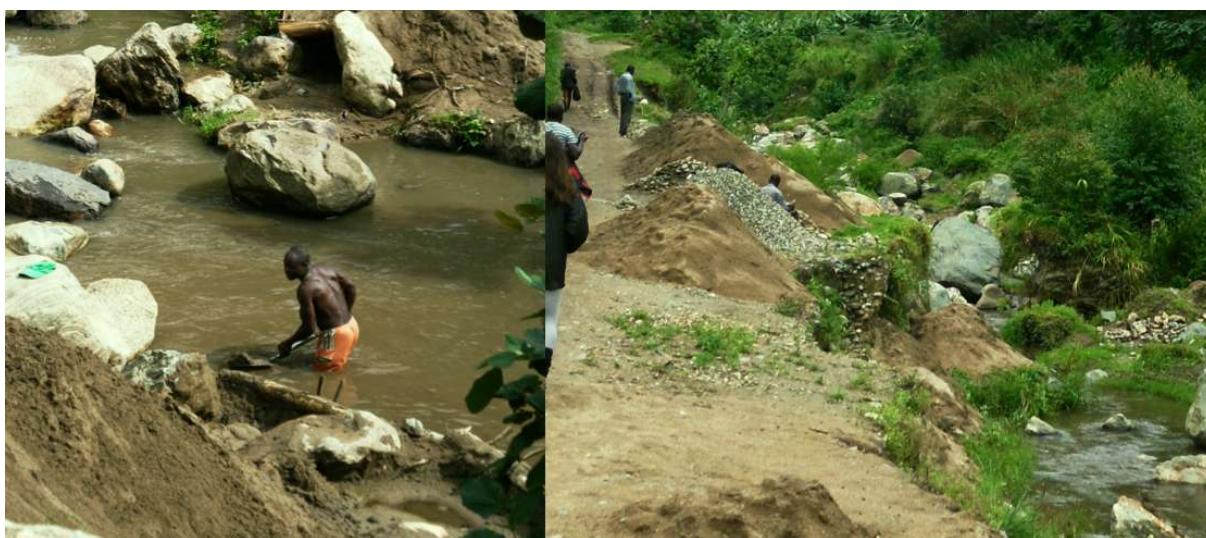
Figure 8. Turbid water and river bed and bank modification due to sediment extraction activities.

The effects of sediment mining are most visible in the elevated turbidity in the headwaters compared to further downstream areas and to the most upstream location UFP8, with only 10 NTU. The location is situated at Mount Gessi Primary School, upstream of all sand mining activity, hence the 3-12 times

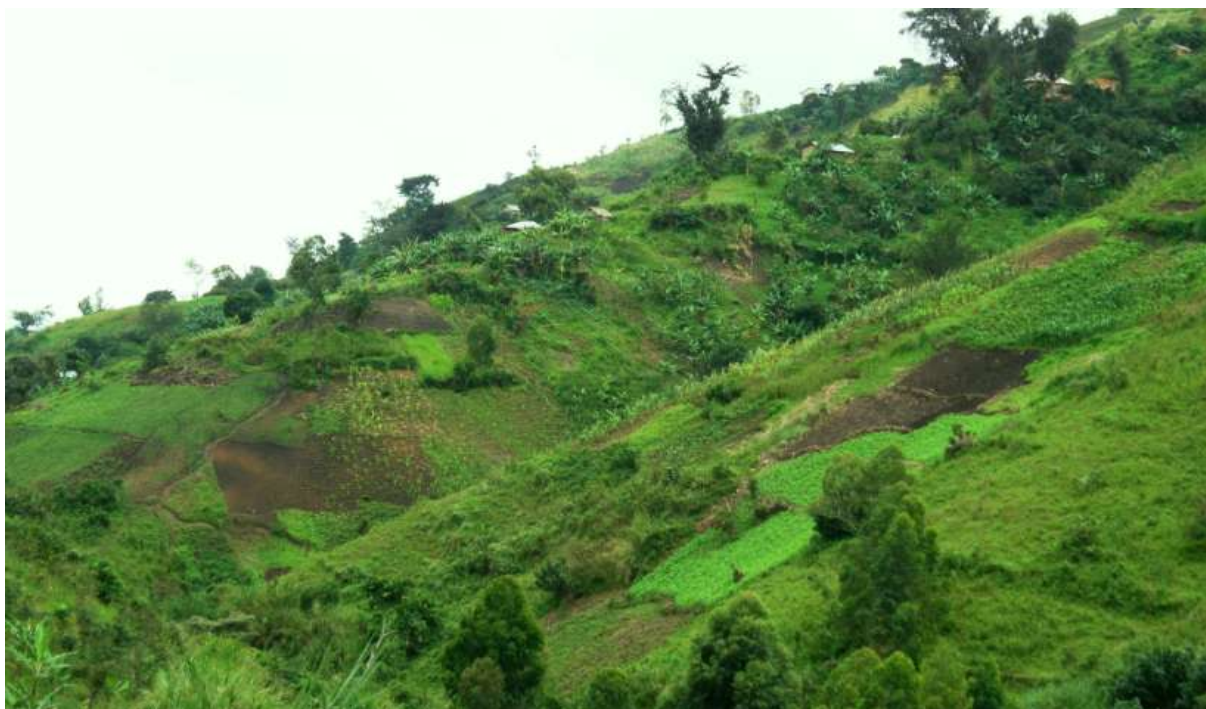
Figure 9. Agricultural land on a deforested Rwenzori mountain slope.

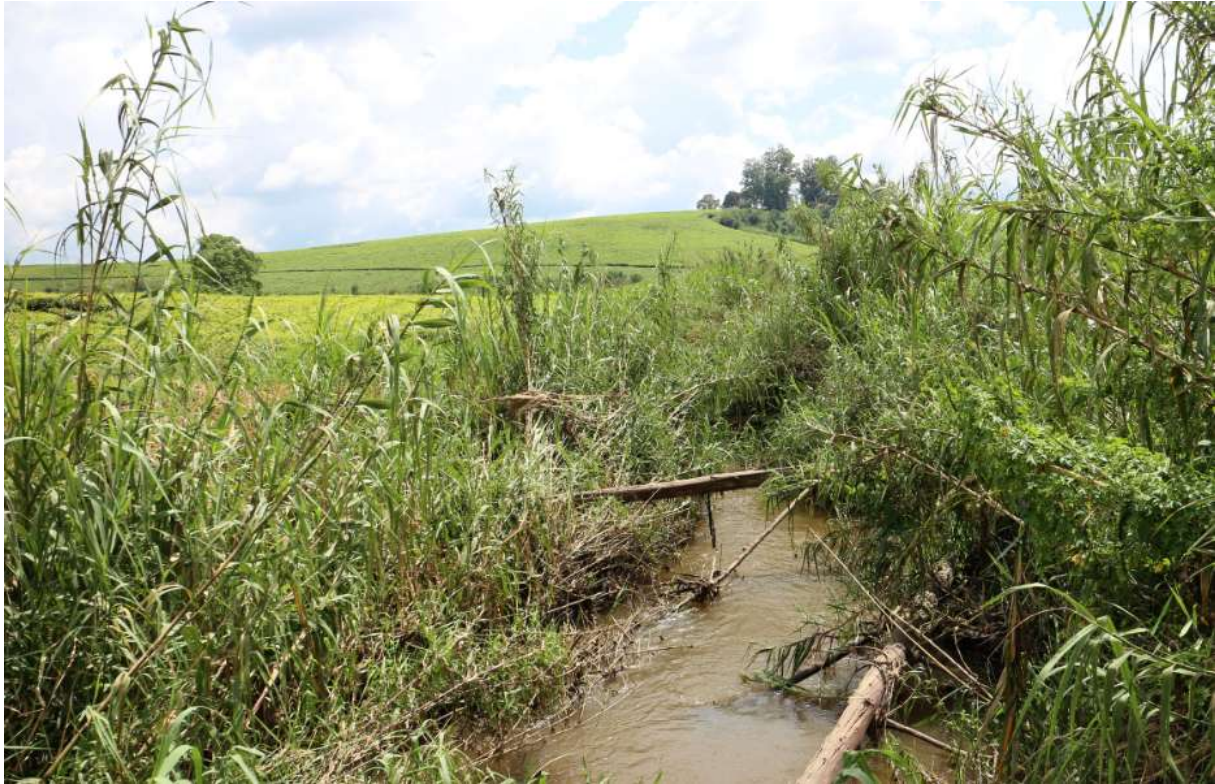
Figure 10. Narrow buffer zone between a tea plantation and the Mpanga main channel (location DFP6).

The biological quality in Mpanga gradually recovers downstream of Fort Portal, while it crosses the tea estates on its way to Kibale Forest. Even though conductivity and turbidity remain unaltered from where the river left Fort Portal ($>430\text{ }\mu\text{S/cm}$, ≈ 25 NTU), phosphate and nitrate levels remain low, with no indication of contamination by ammonium, nitrite or elevated COD levels. Respecting protection zones and allowing bank vegetation to develop more naturally does certainly benefit the river. This is also reflected in the side stream Kibonwa, which, despite running through agricultural area, is kept in a moderate to good state by the wetland surrounding the stream, allowing for a community of 11-14 taxa with an ASPT of ≥ 6 . A particular stream is Nyakunuka (DFP7 and DFP8), which is characterised by oxygen depleted water (9-19 % local DO-saturation), low conductivity and acidic water of a pH around 6. The yellow water is draining from a wetland and is completely covered by plant detritus from the thick reed vegetation emerging from it, hence a high COD (>50 mg/L). An ASPT of 5 indicates that the 9-14 taxa present are adapted to these particular conditions, but no negative impact on the Mpanga river was observed, as indicated by the high biological quality state in location DFP9 (10 taxa, ASPT of 7.8). Thus, from the present observations, it seems that as long as the protection zone between tea plantations and stream is respected, water quality is not further impaired by runoff from the plantations and tea factories (Figure 10).

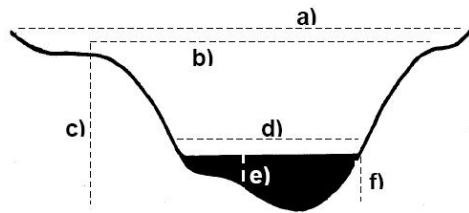
27 cross section

- a) width of floodplain [m] _____
- b) flood prone area width [m] _____
- c) entrenchment depth [m] _____
- d) average stream width [m] _____
- e) mean depth water body [m] _____
- f) maximum depth water body [m] _____
