Water and Sanitation Baseline Study

of Mahyoro and Nyabbani Sub County,
Kamwege District, Uganda

Novembre 2011

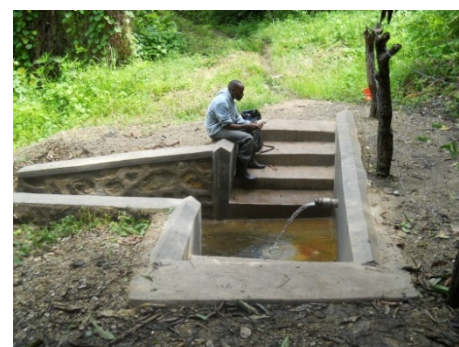
Photo 3: un protected water source, Mahyoro

Unprotected source: a natural source which has not been improved to provide safe water drinking i.e. lake, river, swamp and springs where people step in water they are fetching. This is not an official 'water point', but is mentioned here because it is an important source of water for many people.

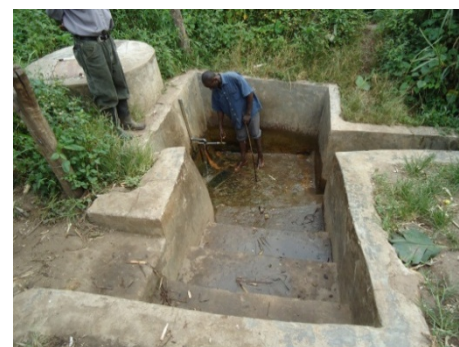
Photo 4: Improved spring, Mahyoro

Improved spring: Comprises of an effective catchment, consisting of a perforated pipe within a trench or dry walled channel (stone package), a supply pipe leading to an inspection chamber which consists of an entry basin for receiving the spring water and an operation chamber which helps control water quantity and quality. Sometimes it can also serve as a sedimentation basin with a tap for water collection.

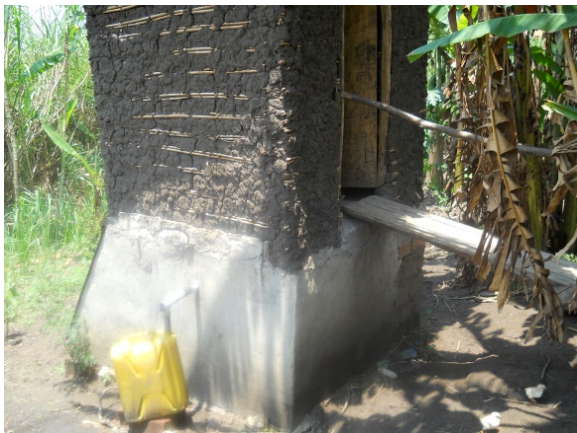
A 3-5 inch (7.5 – 12.5 cm) slab is casted on which two chambers with separated channels for urine and faecal matter/excreta and the superstructure is built. Dry materials, like wood ash, lime and soil, are added to cover the fresh excreta; the chambers are used alternately to allow decomposition, it takes an average family 6 months to fill one of the vaults. Then the second vault is used. The first vault is emptied following an additional 6 months of sanitization and the material is taken to soil compost. Urine is never mixed in this toilet but continuously diverted into a separate container and later used in diluted form as plant fertilizer. In specific cases urine is diverted to a soak pit.

Photo 5: Outside of ecosan with a urine collection unit

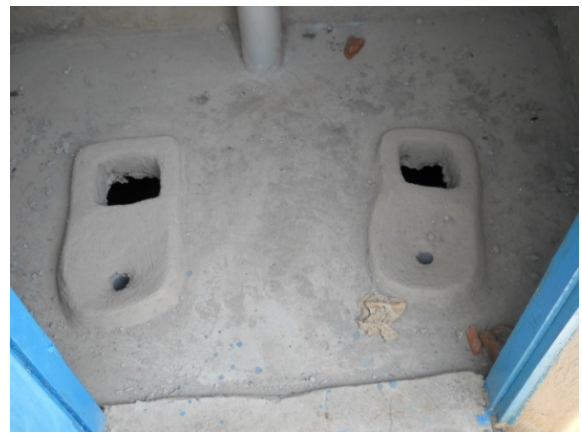
Photo 6: Inside of an ecosan latrine

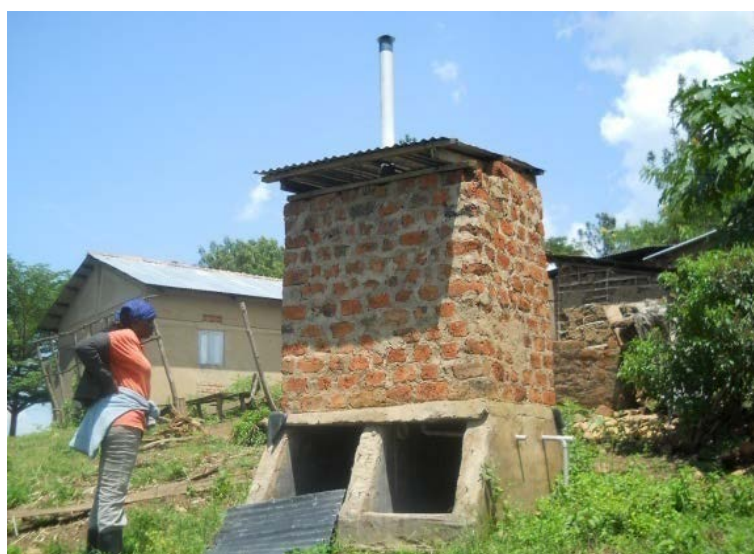
Photo 7: Back of ecosan showing the two chambers

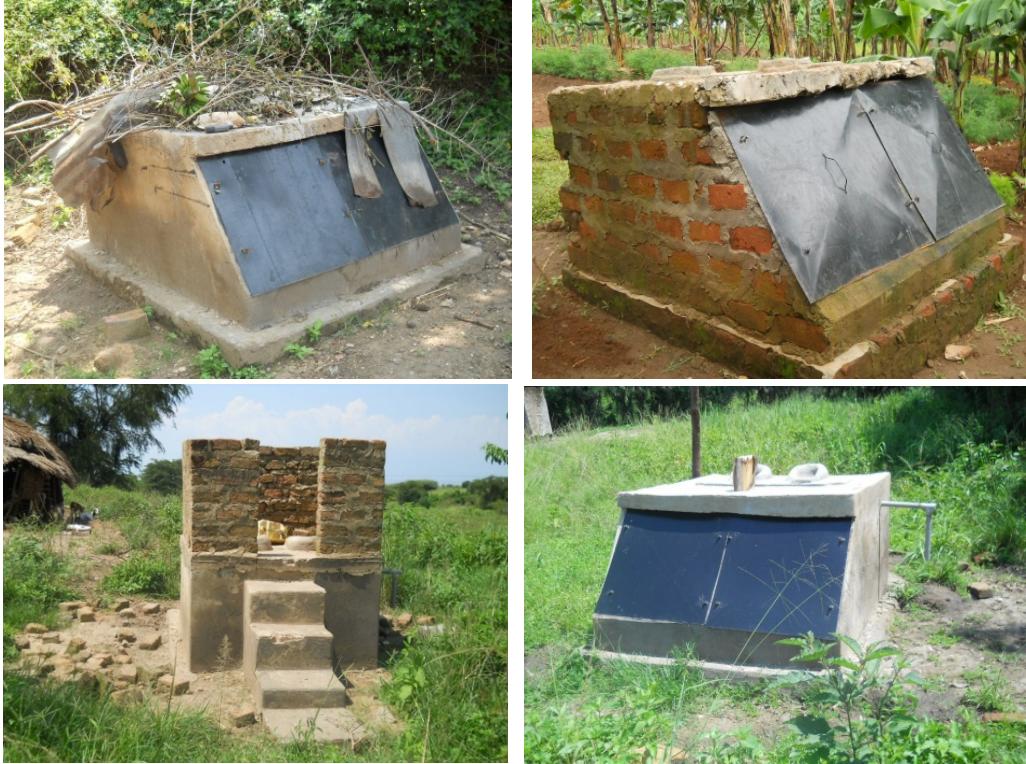
Photo 8: Different upper constructions

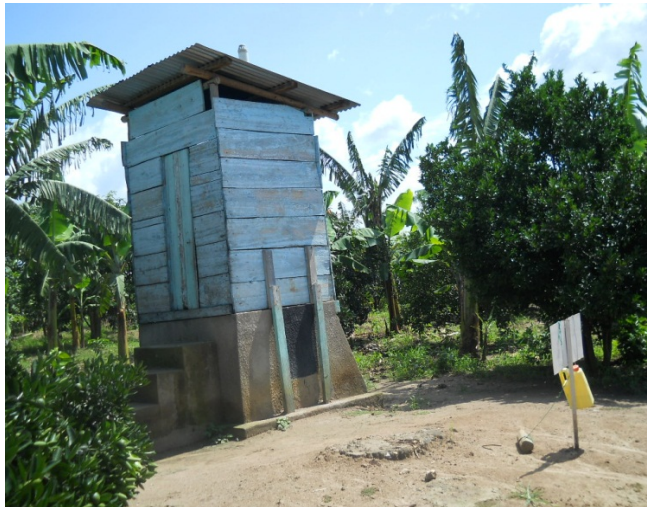
Photo 9: Upper construction in wood

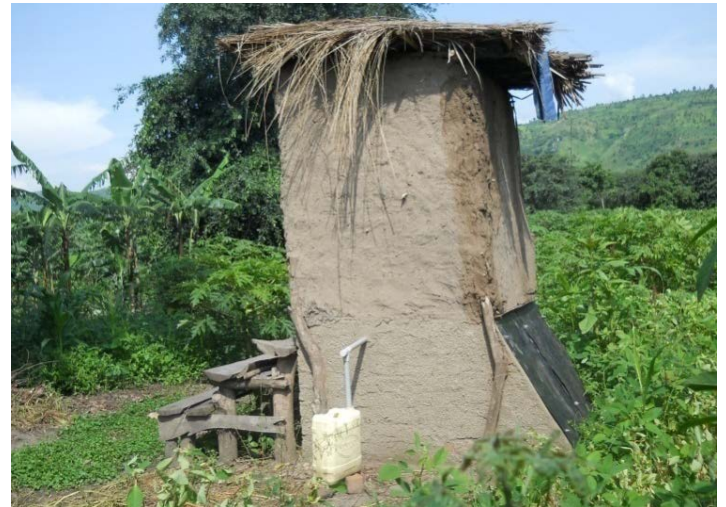
Photo 11: Upper structure in clay and grass thatched

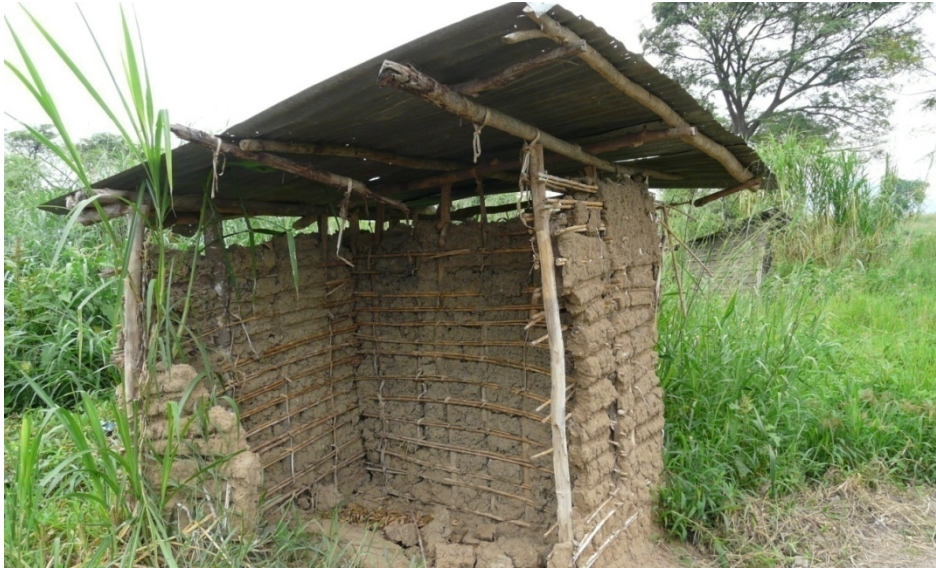
Most households have standard latrines with a pit and some have solid floor/upper structure and a roof. These pit latrines are usually constructed using local materials, mud, reeds, grass for thatching, poles for slab and superstructure.

Photo 12: Ordinary pit latrine in Mahyoro

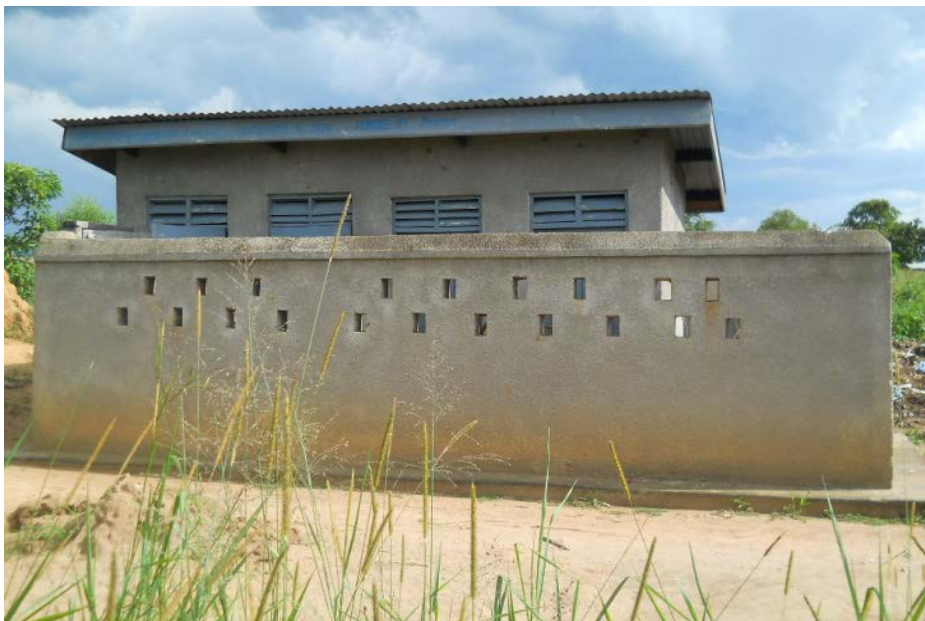
PROTOS/JESE have constructed public latrines at markets (Kyendangala, Katooma) and in schools at Mahyoro Moslem primary

Photo 13: Public pit latrine at Kyendangala market
